#### **Results and Discussion: Performance of Straw Bale Dams**

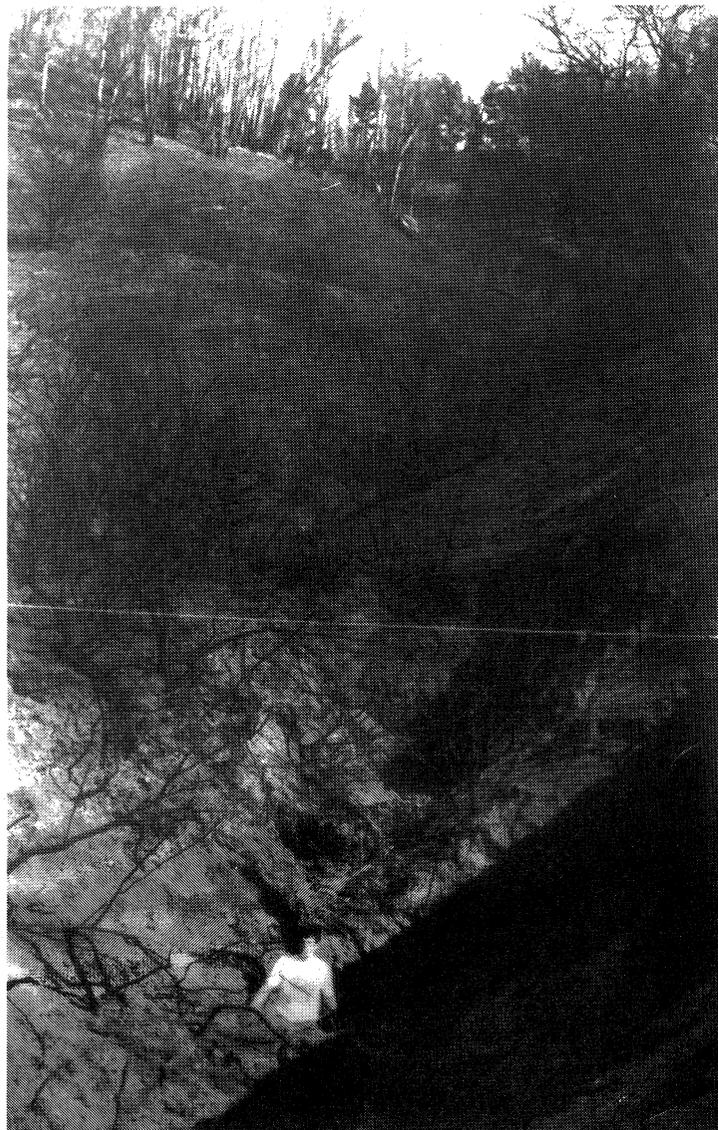
The CCRP watershed has a drainage area of 0.16 km<sup>2</sup>. After the fire ~80% of the drainage area was treated with hydromulch and soil sealant. The vegetation is largely chaparral (predominantly *Baccharis pilularis*), northern coastal scrub (Ornduff 1974) and eucalyptus groves. A continuous gully emanating from road drains and extending through the entire watershed has deeply incised the intermittent channel (Fig. 2). In

its upper reaches exposed bedrock indicated minimal sediment storage prior to bale installation. One dirt trail (~1 km) traverses the uppermost canyon below the urban boundary, but it has been abandoned since the early 1970's.

Figure 2. Photograph of gully in the CCRP site. The tape measure at the top of the gully indicates one of our cross sections.

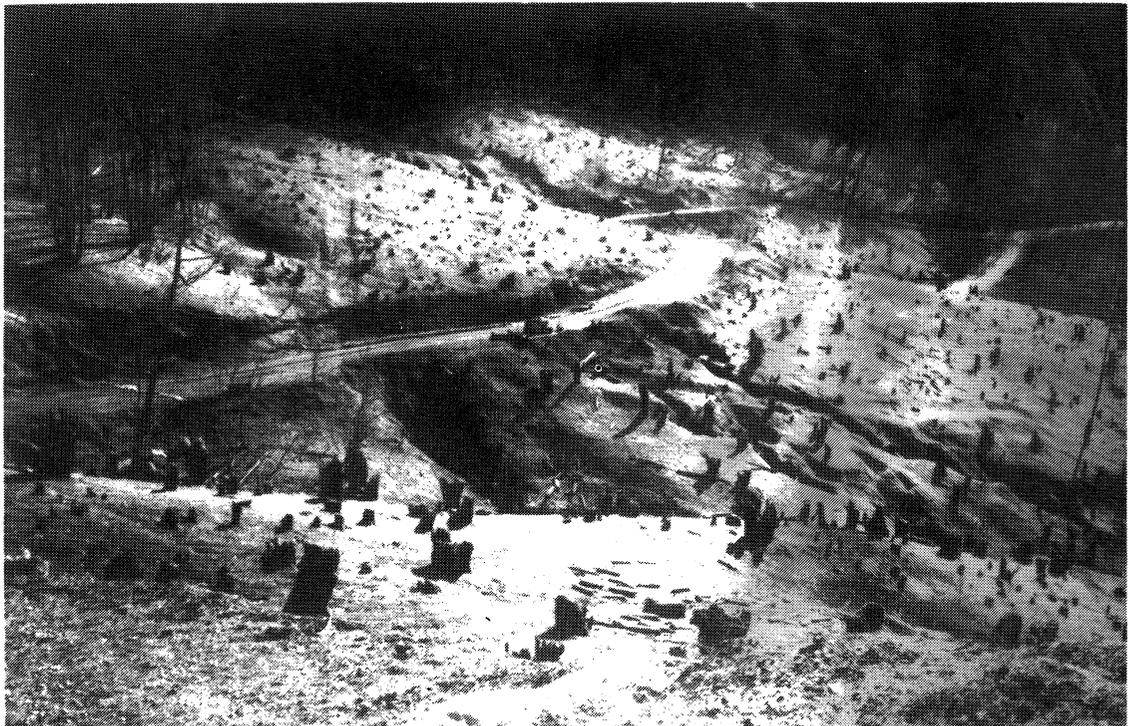
**Figure 3.** Central portion of the NOSC site. Note erosion associated with the dirt road, which was not protected with erosion control measures, even though most of the watershed was aerial seeded, seeded with hydromulch (mixed with soil sealant) and straw bales were added to all the gullies and landslides.

most of the eucalyptus trees were cut (but not killed) about two years prior to the fire (Fig. 3). The NOSC site has a broad flat valley that was created by fill from the excavation of Caldecott Tunnel. At the upper end of the valley fill, at the apex where upland gullies are intersected, a new alluvial fan has developed over the last few decades. Six rows of straw bale barriers ( $n = 112$  bales) were placed on the fan to enhance natural sediment deposition, limit its spread onto the sports green at the lower end of the valley fill, and reduce downstream sedimentation to Lake Temescal.
